REPORTNUMBER: 202404-26053

Report

Subject	Report
Inspection date/location	23.04.2024 Dick Automobile e.K., Ernst-Abbe-Str. 2, DE-36179 Bebra
Client	Dick Automobile e.K., Otto-Hahn-Str. 4-6, DE-36179 Bebra
Registration number	HD-NG 1812
Vehicle Identification Number	WDD2054041F491501

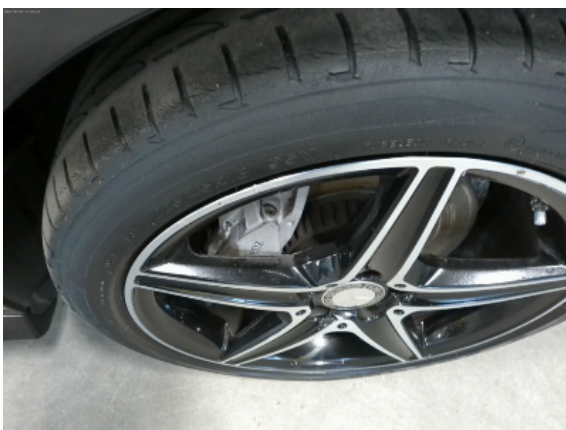
Image 1: Siehe Pos.1

Nr.	Component	Damage	Severity	Comment
1	Aluminium rim FR	Scratch	Severe	
2	Aluminium rim RR	Scratch	Severe	
3	Windshield	Stone chip	Slight	
4	Bonnet	Stone chip	Slight	
5	Bumper front	Stone chip	Slight	
6	Mirror cap left	Stone chip	Slight	
7	Door FL	Stone chip	Slight	
8	Door FL	Scratch	Medium	
9	Door FR	Stone chip	Slight	
10	Mirror cap right	Stone chip	Slight	
11	Tire FL		Severe
