REPORTNUMBER: 202501-29135

## Report

<b>Subject</b>	Report
<b>Inspection date/location</b>	23.01.2025   Dick Automobile e.K., Ernst-Abbe-Str. 2, DE-36179 Bebra
<b>Client</b>	Dick Automobile e.K., Otto-Hahn-Str. 4-6, DE-36179 Bebra
<b>Registration number</b>	F-MC 567
<b>Vehicle Identification Number</b>	W1N2477101J196469

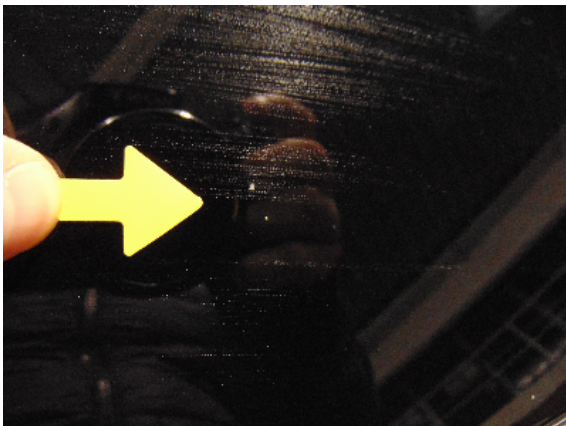
Image 1: siehe pos.1

Nr.	Component	Damage	Severity	Comment
1	Bonnet	Stone chip	Slight	
2	Bumper front	Stone chip	Slight	
3	Mirror cap right	Scratch	Slight	
4	Door FR	Scratch	Slight	
5	Door RR	Dent	Slight	
6	Side panel right	Dent	Slight	
7	Bumper rear	Scratch	Slight	
8	Tailgate panel	Scratch	Slight
