REPORTNUMBER: 202501-29104

Report

Subject	Report
Inspection date/location	21.01.2025 Dick Automobile e.K., Ernst-Abbe-Str. 2, DE-36179 Bebra
Client	Dick Automobile e.K., Otto-Hahn-Str. 4-6, DE-36179 Bebra
Registration number	HD -EL 0273E
Vehicle Identification Number	W1N2539531V254001

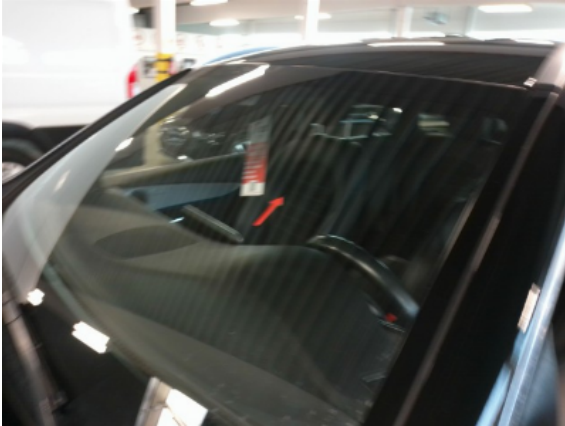
Image 1: Siehe Pos.1

Nr.	Component	Damage	Severity	Comment
1	Windshield	Stone chip	Slight	
2	Bonnet	Stone chip	Slight	
3	Bumper front	Stone chip	Slight	
4	Door FL	Scratch	Slight	
5	Bumper rear	Scratch	Slight	
6	Fender ri	Stone chip	Slight	
7	Bonnet		Severe
