REPORTNUMBER: 202405-26141

Report

Subject	Report
Inspection date/location	02.05.2024 Dick Automobile e.K., Ernst-Abbe-Str. 2, DE-36179 Bebra
Client	Dick Automobile e.K., Otto-Hahn-Str. 4-6, DE-36179 Bebra
Registration number	SÖM-AM 30E
Vehicle Identification Number	WS5B16GAAJA800236

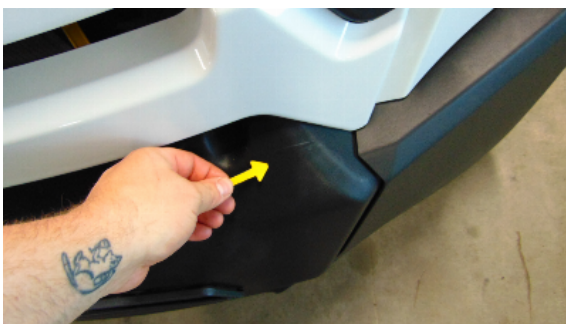
Image 1: siehe pos.1

Nr.	Component	Damage	Severity	Comment
1	Bumper front	Stone chip	Slight	
2	Door FR	Stone chip	Slight	
3	Side panel right	Scratch	Slight	
4	Tailgate	Dent	Slight	
5	Door RL	Scratch	Slight	
6	Door FL	Scratch	Slight
