REPORTNUMBER: 202405-26155

## Report

<b>Subject</b>	Report
<b>Inspection date/location</b>	02.05.2024   Dick Automobile e.K., Ernst-Abbe-Str. 2, DE-36179 Bebra
<b>Client</b>	Dick Automobile e.K., Otto-Hahn-Str. 4-6, DE-36179 Bebra
<b>Registration number</b>	DN-K 9211
<b>Vehicle Identification Number</b>	TMAH3813GLJ066195

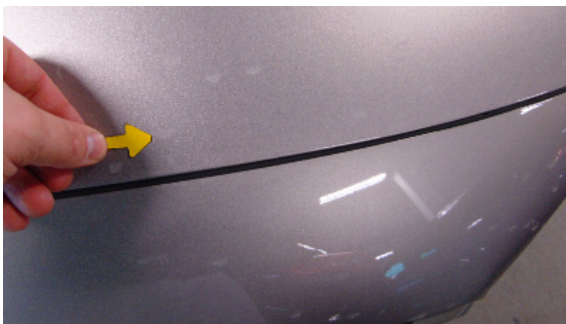
Image 1: siehe pos.1

Nr.	Component	Damage	Severity	Comment
1	Bonnet	Stone chip	Slight	
2	Bumper front	Stone chip	Slight	
3	Mirror cap right		Severe	
4	Tailgate panel	Scratch	Slight	
5	Door FL	Scratch	Slight
