REPORTNUMBER: 202403-25731

Report

Subject	Report
Inspection date/location	27.03.2024 Dick Automobile e.K., Ernst-Abbe-Str. 2, DE-36179 Bebra
Client	Dick Automobile e.K., Otto-Hahn-Str. 4-6, DE-36179 Bebra
Registration number	NR-RM 70
Vehicle Identification Number	VF3VBBHXHGZ040276

Subject	Report
Client	Dick Automobile e.K., Otto-Hahn-Str. 4-6, DE-36179 Bebra
Inspection date/location	27.03.2024 Dick Automobile e.K., Ernst-Abbe-Str. 2, DE-36179 Bebra
Registration number	NR-RM 70
Vehicle type	Van
Manufacturer	Peugeot
Model / Sales description	Expert
Key numbers HSN/TSN	3003 / AWY
Vehicle identification number	VF3VBBHXHGZ040276
Previous owners	2
First registration	22.02.2017
Mileage	112.078 km
Colour / Colour Code	
Fuel Type	Diesel
Cubic Capacity / Power	1.560 cm ³ / 85 kW
Number of doors / seats	5 / 2
Transmission	Manual gearbox
Number of keys	2
Last maintenance	01.08.2019 / 11.415 km
Next vehicle inspection	30.09.2023
Service documentation	Available
Trailer coupling	Fix
Rain sensor	Unavailable
Operating manual	Available
Repainting	Found Plastic parts could not be evaluated by means of paint thickness measurement.
Inspection Condition	non-dismantled, roadworthy, traffic safe

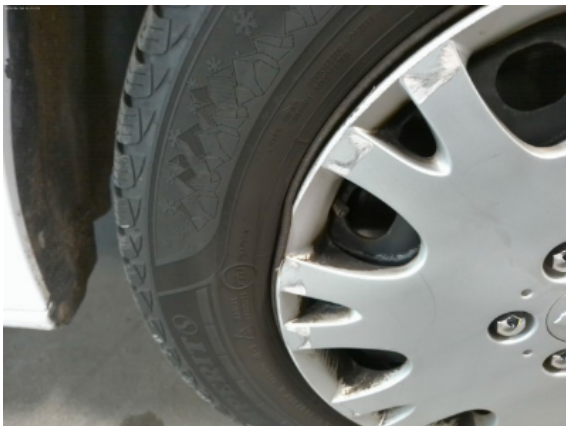
Image 1: Siehe Pos.1

Nr.	Component	Damage	Severity	Comment
1				
2	Windshield	Stone chip	Medium	
3	Bumper front	Scratch	Severe	
4	Bonnet	Stone chip	Slight	
5	Fender le	Scratch	Slight	
6	Door FL	Scratch	Slight	
7	Seat FL	Crack	Severe	
8	Door entry FL	Scratch	Severe	
9	Side panel left	Scratch	Severe	
10	Side panel left	Deformation	Severe	
11	Bumper rear	Crack	Severe	
12	Bumper rear	Scratch	Severe

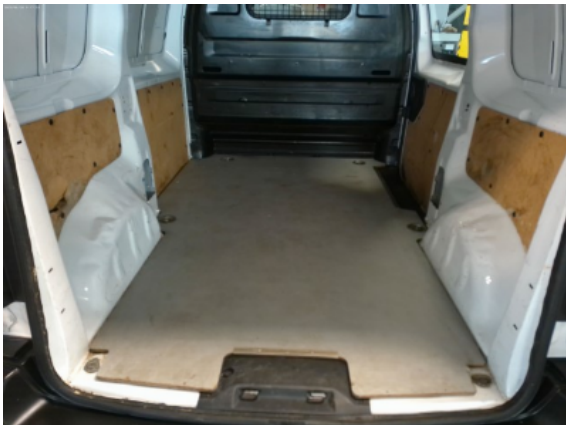
Image 13: Siehe Pos.13

13

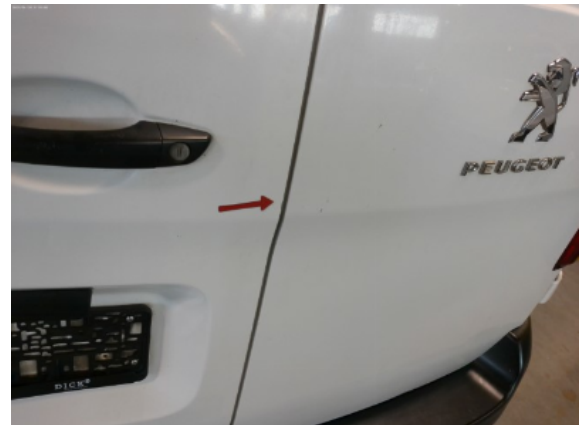
Image 14: Siehe Pos.14

14	Tailgate	Scratch	Medium
15	Tailgate	Deformation	Medium
16	Side panel right	Scratch	Severe
17	Door RR	Scratch	Severe
18	Door FR	Scratch	Severe
19	Door FR	Deformation	Severe
20	Fender ri	Deformation	Severe
