REPORTNUMBER: 202405-26210

Report

Subject	Report
Inspection date/location	07.05.2024 Dick Automobile e.K., Ernst-Abbe-Str. 2, DE-36179 Bebra
Client	Dick Automobile e.K., Otto-Hahn-Str. 4-6, DE-36179 Bebra
Registration number	M-MC1080
Vehicle Identification Number	YV1LC68UCJ1372615

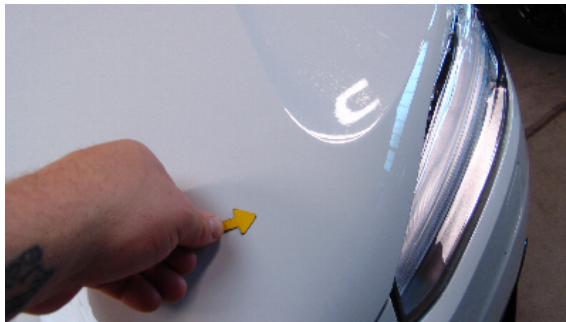
Image 1: siehe pos.1

Nr.	Component	Damage	Severity	Comment
1	Bonnet	Stone chip	Slight	
2	Bumper front	Scratch	Slight	
3	Aluminium rim FR	Scratch	Medium	
4	Bumper rear	Scratch	Slight	
5	Side panel left	Scratch	Slight	
6	Mirror cap left	Scratch	Slight
