REPORTNUMBER: 202409-27672

Report

Subject	Report
Inspection date/location	19.09.2024 Dick Automobile e.K., Ernst-Abbe-Str. 2, DE-36179 Bebra
Client	Dick Automobile e.K., Otto-Hahn-Str. 4-6, DE-36179 Bebra
Registration number	F-TM 3100
Vehicle Identification Number	WBAJJ110805N51301

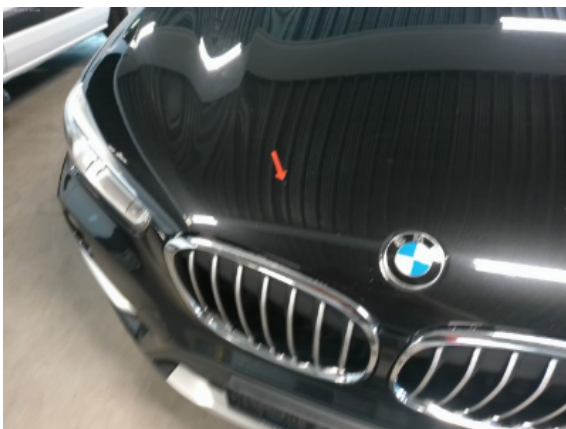
Image 1: Siehe Pos.1

Nr.	Component	Damage	Severity	Comment
1	Bonnet	Stone chip	Slight	
2	Bumper front	Stone chip	Slight	
3	Fender le	Stone chip	Slight	
4	Mirror cap left	Stone chip	Slight	
5	Bumper rear	Scratch	Slight	
6	Door RR	Scratch	Slight	
7	Door FR	Scratch	Slight	
8	Mirror cap right	Stone chip	Slight
