REPORTNUMBER: 202410-27844

## Report

<b>Subject</b>	Report
<b>Inspection date/location</b>	04.10.2024   Dick Automobile e.K., Ernst-Abbe-Str. 2, DE-36179 Bebra
<b>Client</b>	Dick Automobile e.K., Otto-Hahn-Str. 4-6, DE-36179 Bebra
<b>Registration number</b>	F-WD135
<b>Vehicle Identification Number</b>	W0VBD8EV6M8018841

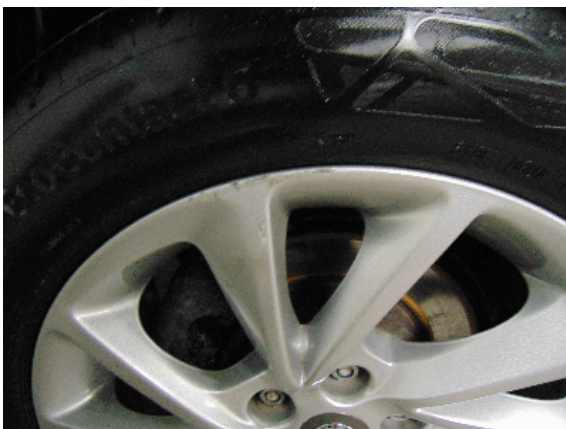
Image 1: siehe pos.1

Nr.	Component	Damage	Severity	Comment
1	Aluminium rim RL	Scratch	Slight	
2	Bonnet	Stone chip	Medium	
3	Bumper front	Stone chip	Slight	
4	Fender ri	Scratch	Slight	
5	Door RR	Scratch	Slight	
6	Side panel right	Scratch	Slight	
7	Fender le	Stone chip	Slight
