REPORTNUMBER: 202504-30003

## Report

<b>Subject</b>	Report
<b>Inspection date/location</b>	08.04.2025   Dick Automobile e.K., Ernst-Abbe-Str. 2, DE-36179 Bebra
<b>Client</b>	Dick Automobile e.K., Otto-Hahn-Str. 4-6, DE-36179 Bebra
<b>Registration number</b>	MOL-CA330
<b>Vehicle Identification Number</b>	WAUZZZF40LA078382

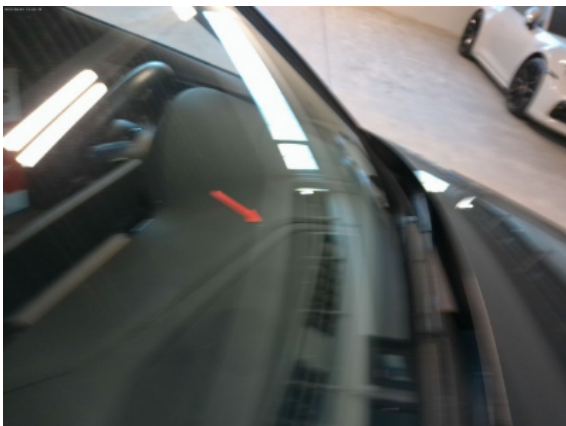
Image 1: Siehe Pos.1

Nr.	Component	Damage	Severity	Comment
1	Windshield	Stone chip	Slight	
2	Bonnet	Stone chip	Slight	
3	Bumper front	Stone chip	Slight	
4	Side panel left	Scratch	Slight	
5	Bumper rear	Scratch	Slight	
6	Mirror cap right	Stone chip	Slight	
7	Mirror cap left	Stone chip	Slight
