REPORTNUMBER: 202404-26035

Report

Subject	Report
Inspection date/location	22.04.2024 Dick Automobile e.K., Ernst-Abbe-Str. 2, DE-36179 Bebra
Client	Dick Automobile e.K., Otto-Hahn-Str. 4-6, DE-36179 Bebra
Registration number	K-HS1490
Vehicle Identification Number	W1N1671211A247809

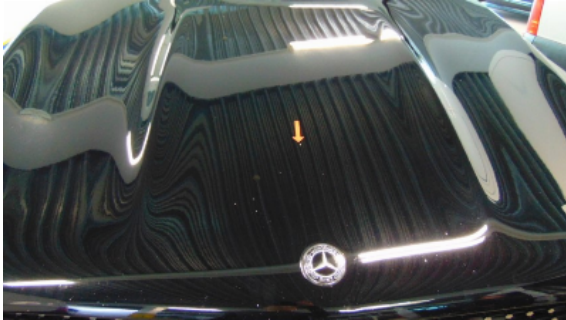
Image 1: Siehe Pos.1

Nr.	Component	Damage	Severity	Comment
1	Bonnet	Stone chip	Slight	
2	Door FL	Dent	Slight	
3	Door entry FL		Slight	
4	Seat FL	Crack	Severe	
5	Door RL	Scratch	Slight	
6	Bumper rear	Scratch	Slight	
7	Tailgate panel	Scratch	Slight	
8	Door entry RR	Scratch	Slight	
9	Door panel RR	Scratch	Slight	
10	Door FR		Slight	
11	Fender ri	Stone chip	Slight
