REPORTNUMBER: 202404-26069

## Report

<b>Subject</b>	Report
<b>Inspection date/location</b>	25.04.2024   Dick Automobile e.K., Ernst-Abbe-Str. 2, DE-36179 Bebra
<b>Client</b>	Dick Automobile e.K., Otto-Hahn-Str. 4-6, DE-36179 Bebra
<b>Registration number</b>	WN-MJ291E
<b>Vehicle Identification Number</b>	W1N1671171A258171

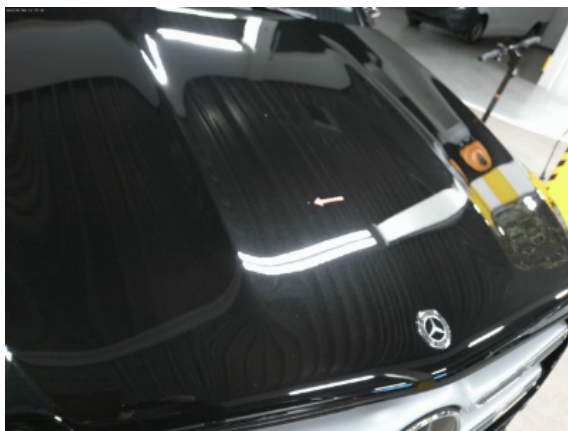
Image 1: Siehe Pos.1

Nr.	Component	Damage	Severity	Comment
1	Bonnet	Stone chip	Slight	
2	Bumper front	Stone chip	Slight	
3	Door entry FL	Scratch	Slight	
4	Door RL	Scratch	Slight	
5	Bumper rear	Scratch	Slight	
6	Door entry RR	Scratch	Slight
