REPORTNUMBER: 202403-25483

## Report

<b>Subject</b>	Report
<b>Inspection date/location</b>	11.03.2024   Dick Automobile e.K., Ernst-Abbe-Str. 2, DE-36179 Bebra
<b>Client</b>	Dick Automobile e.K., Otto-Hahn-Str. 4-6, DE-36179 Bebra
<b>Registration number</b>	LB-HO 266E
<b>Vehicle Identification Number</b>	W1N1671171A285354

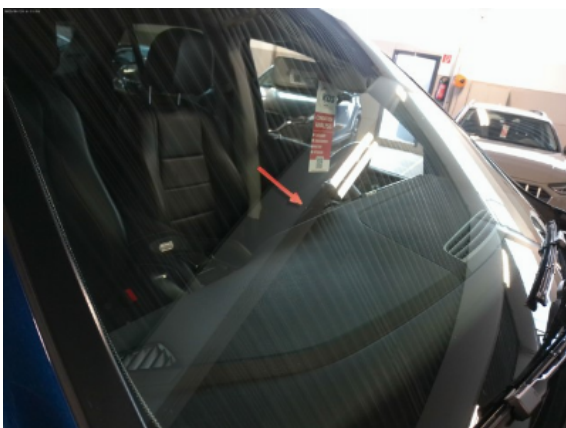
Image 1: Siehe Pos.1

Nr.	Component	Damage	Severity	Comment
1	Windshield	Stone chip	Slight	
2	Bonnet	Stone chip	Slight	
3	Bumper front	Stone chip	Slight	
4	Door FL	Stone chip	Slight	
5	Bumper rear	Scratch	Slight	
6	Door RR	Scratch	Slight
