REPORTNUMBER: 202502-29267

Report

Subject	Report
Inspection date/location	04.02.2025 Dick Automobile e.K., Ernst-Abbe-Str. 2, DE-36179 Bebra
Client	Dick Automobile e.K., Otto-Hahn-Str. 4-6, DE-36179 Bebra
Registration number	GP-KA721E
Vehicle Identification Number	W1N1671171A413952

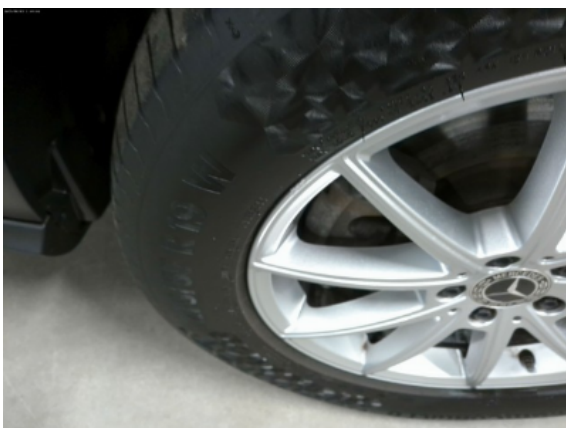
Image 1: Siehe Pos.1

Nr.	Component	Damage	Severity	Comment
1	Aluminium rim FR	Scratch	Severe	
2	Windshield	Stone chip	Slight	
3	Bonnet	Stone chip	Slight	
4	Fender le	Stone chip	Slight	
5	Mirror cap left	Stone chip	Slight	
6	Side panel left	Scratch	Slight	
7	Bumper rear	Scratch	Slight	
8	Door RR	Scratch	Slight	
9	Mirror cap right	Stone chip	Slight
