REPORTNUMBER: 202404-25927

Report

Subject	Report
Inspection date/location	15.04.2024 Dick Automobile e.K., Ernst-Abbe-Str. 2, DE-36179 Bebra
Client	Dick Automobile e.K., Otto-Hahn-Str. 4-6, DE-36179 Bebra
Registration number	RO-RL95
Vehicle Identification Number	SADCA2BX9LA649864

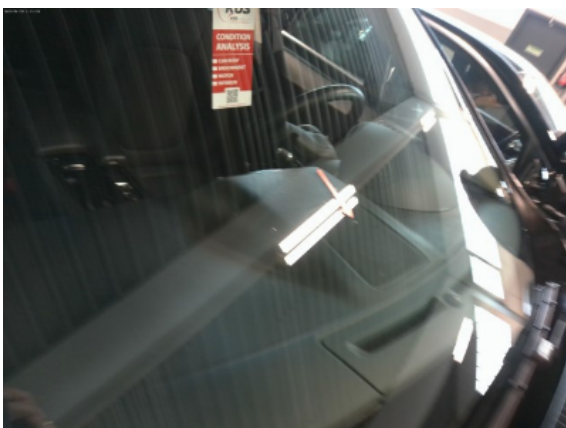
Image 1: Siehe Pos.1

Nr.	Component	Damage	Severity	Comment
1	Windshield	Stone chip	Slight	
2	Bonnet	Stone chip	Slight	
3	Bumper front	Stone chip	Slight	
4	Fender le	Stone chip	Slight	
5	Mirror cap left	Scratch	Medium	
6	Door FL	Scratch		
7	Tailgate	Scratch	Medium	
8	Bumper rear
