REPORTNUMBER: 202404-25886

<b>Subject</b>	Report
<b>Inspection date/location</b>	11.04.2024   Dick Automobile e.K., Ernst-Abbe-Str. 2, DE-36179 Bebra
<b>Client</b>	Dick Automobile e.K., Otto-Hahn-Str. 4-6, DE-36179 Bebra
<b>Registration number</b>	H-AV2166
<b>Vehicle Identification Number</b>	WBA8T91080B218976

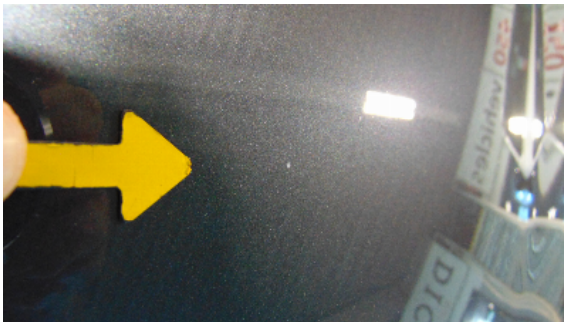
Image 1: siehe pos.1

Nr.	Component	Damage	Severity	Comment
1	Bonnet	Stone chip	Slight	
2	Bumper front	Stone chip	Slight	
3	Door FR	Scratch	Slight	
4	Mirror cap right	Scratch	Slight	
5	Tailgate	Scratch	Slight	
6	Bumper rear	Scratch	Slight
