Gerlach & Schröder GbR
Nürnberger Str. 34
DE-36199 Rotenburg a.d. Fulda/Lisp.

REPORTNUMBER: 202403-25536

Report

Subject	Report
Inspection date/location	14.03.2024 Dick Automobile e.K., Ernst-Abbe-Str. 2, DE-36179 Bebra
Client	Dick Automobile e.K., Otto-Hahn-Str. 4-6, DE-36179 Bebra
Registration number	F-HE 1674
Vehicle Identification Number	WBAJT51070BU74861

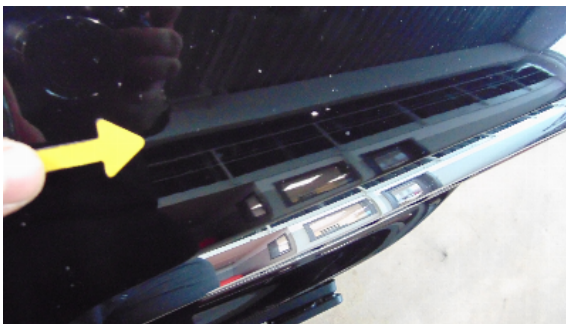
Image 1: siehe pos.1

Nr.	Component	Damage	Severity	Comment
1	Bonnet	Stone chip	Slight	
2	Bumper front	Stone chip	Slight	
3	Fender ri	Scratch	Slight	
4	Door FR	Scratch	Slight	
5	Door RR	Scratch	Slight	
6	Side panel right	Scratch	Slight	
7	Bumper rear	Scratch	Slight	
8	Side panel left	Scratch	Slight	
9	Door FL	Scratch	Slight	
10	Fender le	Scratch	Slight
