REPORTNUMBER: 202404-26016

## Report

<b>Subject</b>	Report
<b>Inspection date/location</b>	20.04.2024   Dick Automobile e.K., Ernst-Abbe-Str. 2, DE-36179 Bebra
<b>Client</b>	Dick Automobile e.K., Otto-Hahn-Str. 4-6, DE-36179 Bebra
<b>Registration number</b>	KA-HI3210
<b>Vehicle Identification Number</b>	WBAJR71030CD58547

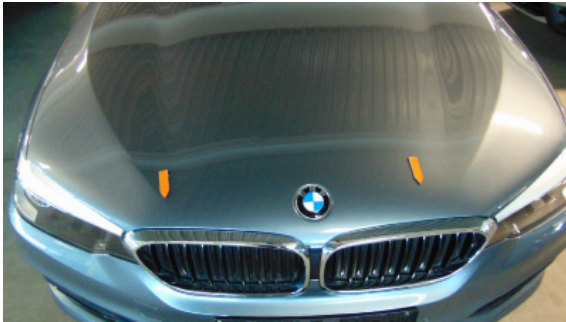
Image 1: Siehe Pos.1

Nr.	Component	Damage	Severity	Comment
1	Bonnet	Stone chip	Slight	
2	Windshield	Stone chip	Medium	
3	Door FR		Slight	
4	Seat FL		Slight	
5	Centre console		Slight	
6	Aluminium rim FL		Slight	
7	Fender ri		Slight	
8	Mirror cap right		Slight	
9	Door FR		Slight	
10	Door RR		Slight	
11	Tailgate		Medium	
12	Bumper front		Slight
