Report

Subject	Report
Inspection date/location	19.09.2024 Dick Automobile e.K., Ernst-Abbe-Str. 2, DE-36179 Bebra
Client	Dick Automobile e.K., Otto-Hahn-Str. 4-6, DE-36179 Bebra
Registration number	OF-FA9301
Vehicle Identification Number	SALCA2BN6LH877475

Subject	Report
Client	Dick Automobile e.K., Otto-Hahn-Str. 4-6, DE-36179 Bebra
Inspection date/location	19.09.2024 Dick Automobile e.K., Ernst-Abbe-Str. 2, DE-36179 Bebra
Registration number	OF-FA9301
Vehicle type	SUV/Off-road Vehicle/Pickup Truck
Manufacturer	Land Rover
Model / Sales description	Discovery Sport D150
Key numbers HSN/TSN	/
Vehicle identification number	SALCA2BN6LH877475
Previous owners	1
First registration	16.11.2020
Mileage	147.295 km
Colour / Colour Code	Santorini Black Metallic
Fuel Type	Diesel
Cubic Capacity / Power	1.999 cm ³ / 110 kW
Number of doors / seats	5 / 5
Transmission	Automatic transmission
Number of keys	
Last maintenance	11.01.2024 / 145.428 km
Next vehicle inspection	
Service documentation	Available
Trailer coupling	Swiveling
Rain sensor	Available
Operating manual	Available
Repainting	Not Found Plastic parts could not be evaluated by means of paint thickness measurement.
Inspection Condition	non-

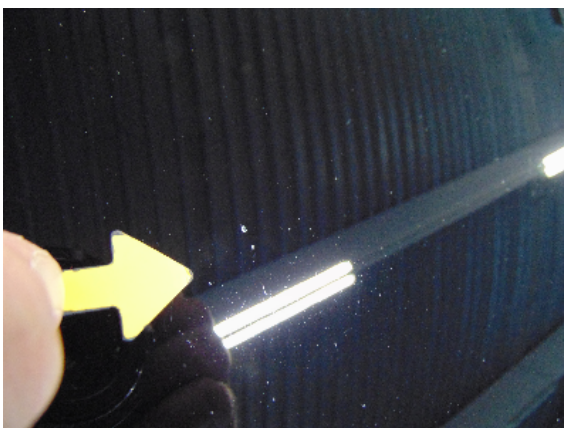
Image 1: siehe pos.1

Nr.	Component	Damage	Severity	Comment
1	Bonnet	Stone chip	Slight	
2	Bumper front	Stone chip	Slight	
3	Mirror cap right	Scratch	Slight	
4	Tailgate panel	Scratch	Slight
