REPORTNUMBER: 202502-29245

Report

Subject	Report
Inspection date/location	31.01.2025 Dick Automobile e.K., Ernst-Abbe-Str. 2, DE-36179 Bebra
Client	Dick Automobile e.K., Otto-Hahn-Str. 4-6, DE-36179 Bebra
Registration number	MZ-DA620
Vehicle Identification Number	WAUZZZF29LN094023

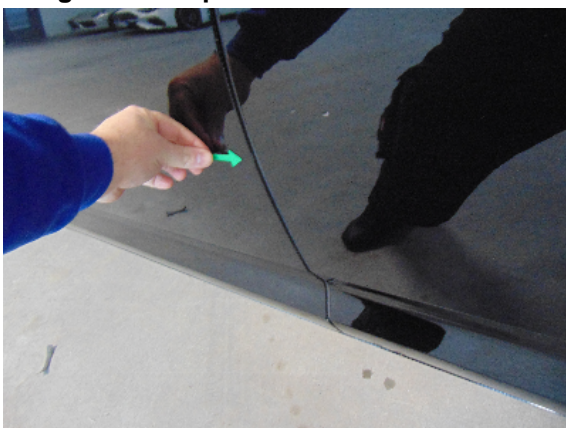
Image 7: siehe pos.7

- Fender ri.; ~ 200µm

A sample-like paint thickness measurement showed an increased paint thickness, which is almost certainly due to a repaired damage.
