REPORTNUMBER: 202501-29233

## Report

<b>Subject</b>	Report
<b>Inspection date/location</b>	31.01.2025   Dick Automobile e.K., Ernst-Abbe-Str. 2, DE-36179 Bebra
<b>Client</b>	Dick Automobile e.K., Otto-Hahn-Str. 4-6, DE-36179 Bebra
<b>Registration number</b>	
<b>Vehicle Identification Number</b>	WDC2533091F433547

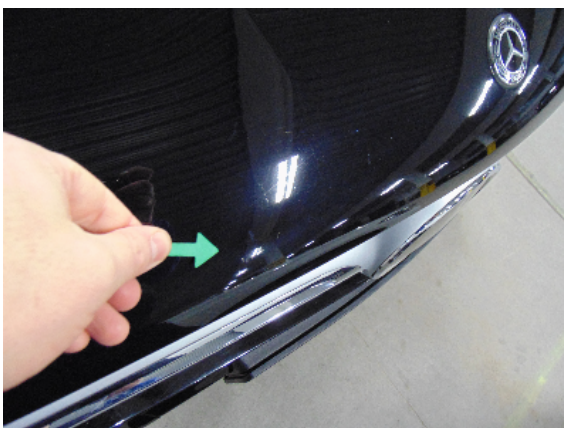
Image 1: siehe pos.1

Nr.	Component	Damage	Severity	Comment
1	Bonnet	Stone chip	Slight	
2	Bumper front	Stone chip	Slight	
3	Door RR	Scratch	Slight
