REPORTNUMBER: 202405-26361

## Report

<b>Subject</b>	Report
<b>Inspection date/location</b>	17.05.2024   Dick Automobile e.K., Ernst-Abbe-Str. 2, DE-36179 Bebra
<b>Client</b>	Dick Automobile e.K., Otto-Hahn-Str. 4-6, DE-36179 Bebra
<b>Registration number</b>	MEG O 6262
<b>Vehicle Identification Number</b>	WBA8C51020K732752

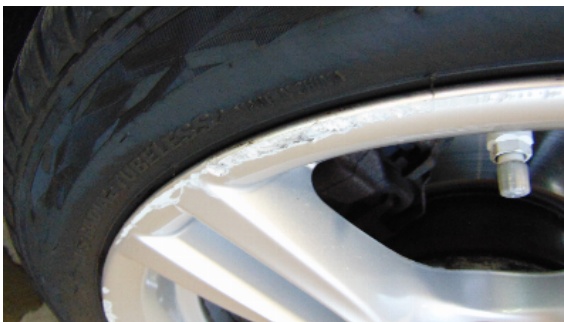
Image 1: siehe pos.1

Nr.	Component	Damage	Severity	Comment
1	Aluminium rim FR	Scratch	Medium	
2	Aluminium rim RL	Scratch	Medium	
3	Aluminium rim FL	Scratch	Medium	
4	Bonnet	Stone chip	Slight	
5	Fender ri	Dent	Slight	
6	Bumper rear	Scratch	Slight	
7	Tailgate panel	Scratch	Slight	
8	Door RL	Scratch	Slight	
9	Door FL	Scratch	Slight
