REPORTNUMBER: 202405-26242

Report

Subject	Report
Inspection date/location	10.05.2024 Dick Automobile e.K., Ernst-Abbe-Str. 2, DE-36179 Bebra
Client	Dick Automobile e.K., Otto-Hahn-Str. 4-6, DE-36179 Bebra
Registration number	GD-LE 12
Vehicle Identification Number	TMBJJ7NU7L2025508

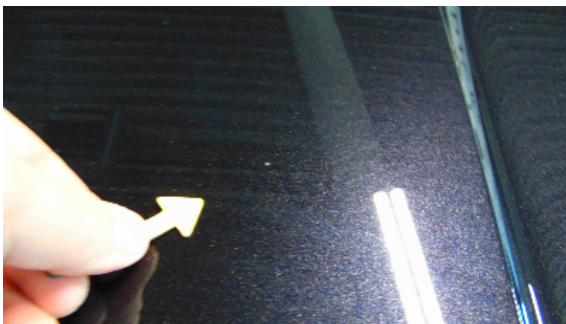
Image 1: siehe pos.1

Nr.	Component	Damage	Severity	Comment
1	Bonnet	Stone chip	Slight	
2	Bumper front	Stone chip	Slight	
3	Door RR	Scratch	Slight	
4	Side panel right	Scratch	Slight	
5	Door RL	Scratch	Slight
