REPORTNUMBER: 202403-25675

Report

Subject	Report
Inspection date/location	26.03.2024 Dick Automobile e.K., Ernst-Abbe-Str. 2, DE-36179 Bebra
Client	Dick Automobile e.K., Otto-Hahn-Str. 4-6, DE-36179 Bebra
Registration number	LH-AB 1416
Vehicle Identification Number	TMBLJ7NU7M5013836

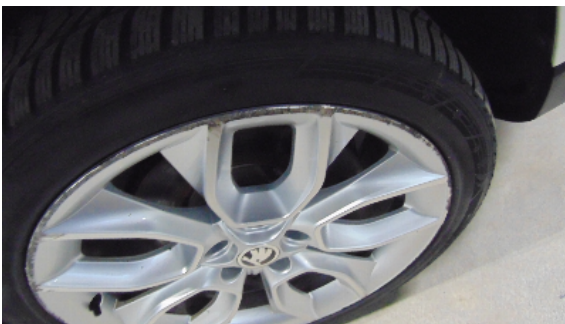
Image 1: siehe pos.1

Nr.	Component	Damage	Severity	Comment
1	Aluminium rim FR	Scratch	Medium	
2	Aluminium rim RR	Scratch	Medium	
3	Aluminium rim FL	Scratch	Medium	
4	Windshield	Stone chip	Slight	
5	Bonnet	Stone chip	Slight	
6	Bumper front	Stone chip	Slight	
7	Side panel right	Dent	Slight
