REPORTNUMBER: 202404-26084

Report

Subject	Report
Inspection date/location	25.04.2024 Dick Automobile e.K., Ernst-Abbe-Str. 2, DE-36179 Bebra
Client	Dick Automobile e.K., Otto-Hahn-Str. 4-6, DE-36179 Bebra
Registration number	WL-BD 1576
Vehicle Identification Number	WBA6X310305R05581

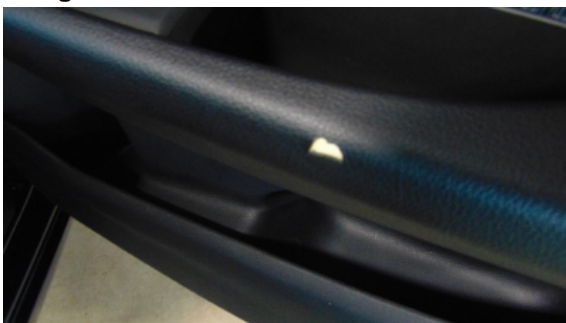
Image 13: Siehe Pos.13

13	Door panel RR		Severe
14	Roof	Stone chip	Slight
