REPORTNUMBER: 202404-25996

Report

Subject	Report
Inspection date/location	19.04.2024 Dick Automobile e.K., Ernst-Abbe-Str. 2, DE-36179 Bebra
Client	Dick Automobile e.K., Otto-Hahn-Str. 4-6, DE-36179 Bebra
Registration number	
Vehicle Identification Number	VF1RFB00356365261

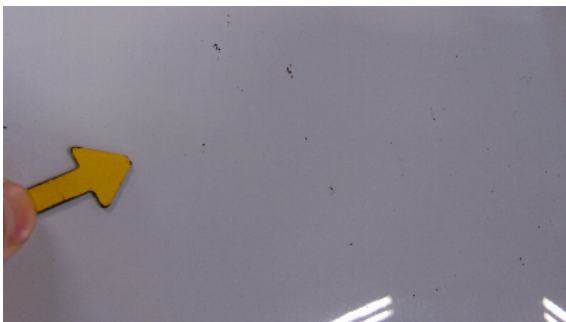
Image 1: siehe pos.1

Nr.	Component	Damage	Severity	Comment
1	Bonnet	Stone chip	Slight	
2	Bumper front	Stone chip	Slight	
3	Door RR	Scratch	Slight	
4	Door entry RR	Scratch	Slight	
5	Bumper rear	Scratch	Slight	
6	Aluminium rim FR	Paint chipping	Medium	
7	Aluminium rim RR	Paint chipping	Medium	
8	Aluminium rim RL	Paint chipping	Medium	
9	Aluminium rim FL	Paint chipping	Medium
