REPORTNUMBER: 202404-25906

Report

Subject	Report
Inspection date/location	12.04.2024 Dick Automobile e.K., Ernst-Abbe-Str. 2, DE-36179 Bebra
Client	Dick Automobile e.K., Otto-Hahn-Str. 4-6, DE-36179 Bebra
Registration number	B-MK 2115
Vehicle Identification Number	WBA1S710307D79640

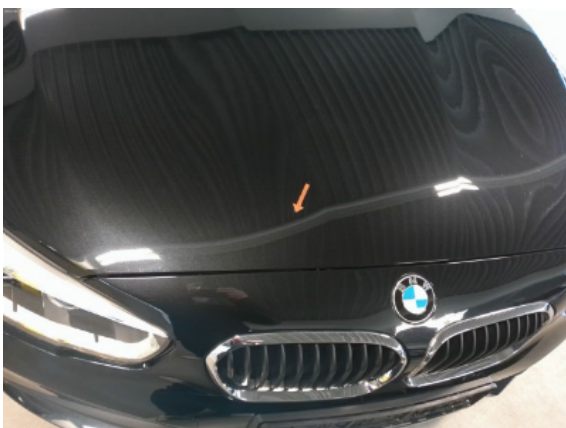
Image 1: Siehe Pos.1

Nr.	Component	Damage	Severity	Comment
1	Bonnet	Stone chip	Slight	
2	Bumper front	Stone chip	Slight	
3	Fender le	Stone chip	Slight	
4	Door FL	Scratch	Slight	
5	Door entry FL	Scratch	Slight	
6	Door RL	Scratch	Slight	
7	Bumper rear	Scratch	Slight	
8	Side panel left	Dent	Slight	
9	Bonnet	Dent	Slight
