REPORTNUMBER: 202404-26093

Report

Subject	Report
Client	Dick Automobile e.K., Otto-Hahn-Str. 4-6, DE-36179 Bebra
Inspection date/location	26.04.2024 Dick Automobile e.K., Ernst-Abbe-Str. 2, DE-36179 Bebra
Registration number	
Vehicle type	Estate Car
Manufacturer	BMW
Model / Sales description	120d xDrive Aut.
Key numbers HSN/TSN	/
Vehicle identification number	WBA7N510207F59956
Previous owners	1
First registration	13.02.2020
Mileage	155.279 km
Colour / Colour Code	ROT
Fuel Type	Diesel
Cubic Capacity / Power	1.995 cm ³ / 140 kW
Number of doors / seats	5 / 5
Transmission	Automatic transmission
Number of keys	1
Last maintenance	17.01.2024 / 147.409 km
Next vehicle inspection	01.09.2025
Service documentation	Available
Trailer coupling	No
Rain sensor	Available
Operating manual	Available
Repainting	Not Found Plastic parts could not be evaluated by means of paint thickness measurement.
Inspection Condition	non-dismantled, roadworthy, traffic safe

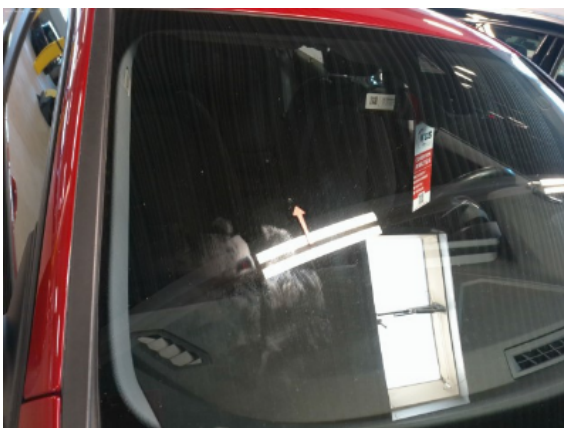
Image 1: Siehe Pos.1

Nr.	Component	Damage	Severity	Comment
1	Windshield	Stone chip	Slight	
2	Bonnet	Stone chip	Slight	
3	Bumper front	Stone chip	Slight	
4	Door FL	Scratch	Slight	
5		Scratch	Medium	
6	Bumper rear	Scratch	Slight	
7	Side panel right	Scratch	Slight
