REPORTNUMBER: 202404-25909

Report

Subject	Report
Inspection date/location	12.04.2024 Dick Automobile e.K., Ernst-Abbe-Str. 2, DE-36179 Bebra
Client	Dick Automobile e.K., Otto-Hahn-Str. 4-6, DE-36179 Bebra
Registration number	KO-NE 4417
Vehicle Identification Number	VF1RFB00958573570

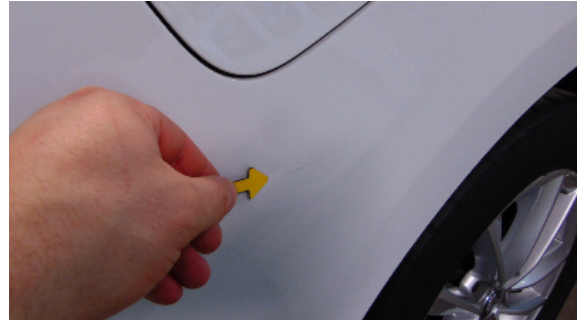
Image 6: siehe pos.6

Nr.	Component	Damage	Severity	Comment
1	Bonnet	Stone chip	Slight	
2	Bumper front	Stone chip	Slight	
3	Mirror cap right	Scratch	Slight	
4	Door entry FR	Scratch	Slight	
5	Door entry RR	Scratch	Slight	
6	Side panel right	Scratch	Slight	
7	Bumper rear	Scratch	Slight	
8	Side panel left	Scratch	Slight	
9	Door entry FL	Scratch	Slight	
10	Mirror cap left	Scratch	Slight

- Side panel ri.; ~ 190µm

A sample-like paint thickness measurement showed an increased paint thickness, which is almost certainly due to a repaired damage.
