Gerlach & Schröder GbR
Nürnberger Str. 34
DE-36199 Rotenburg a.d. Fulda/Lisp.

REPORTNUMBER: 202404-26029

Report

Subject	Report
Inspection date/location	22.04.2024 Dick Automobile e.K., Ernst-Abbe-Str. 2, DE-36179 Bebra
Client	Dick Automobile e.K., Otto-Hahn-Str. 4-6, DE-36179 Bebra
Registration number	WO-R 1403
Vehicle Identification Number	WVWZZZ3CZGE156715

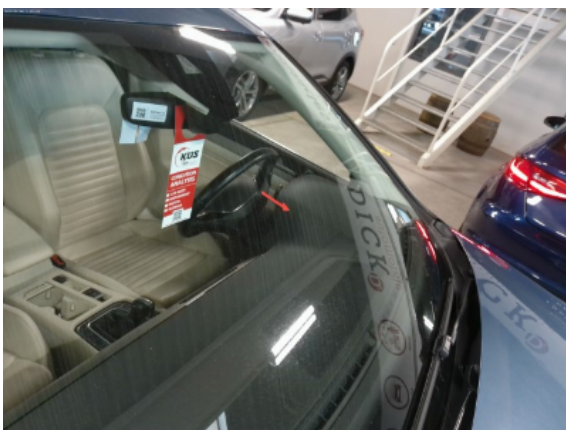
Image 1: Siehe Pos.1

Nr.	Component	Damage	Severity	Comment
1	Windshield	Stone chip	Slight	
2	Bonnet	Stone chip	Slight	
3	Bumper front	Stone chip	Slight	
4	Mirror cap left	Stone chip	Slight	
5	Door RL	Scratch	Slight	
6	Bumper rear	Stone chip	Medium	
7	Side panel right	Stone chip	Slight	
8	Fender ri	Stone chip	Slight	
9	Bonnet		Slight	
10	Roof		Slight	
11	Tailgate		Slight
