REPORTNUMBER: 202404-25894

## Report

<b>Subject</b>	Report
<b>Inspection date/location</b>	11.04.2024   Dick Automobile e.K., Ernst-Abbe-Str. 2, DE-36179 Bebra
<b>Client</b>	Dick Automobile e.K., Otto-Hahn-Str. 4-6, DE-36179 Bebra
<b>Registration number</b>	
<b>Vehicle Identification Number</b>	W1K1771121J281348

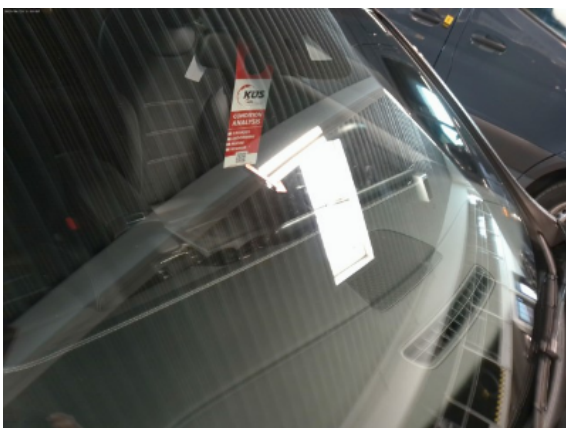
Image 1: Siehe Pos.1

Nr.	Component	Damage	Severity	Comment
1	Windshield	Stone chip	Slight	
2	Bonnet	Stone chip	Slight	
3	Bonnet	Scratch	Severe	
4	Bumper front	Scratch	Medium	
5	Roof	Scratch	Medium	
6	Mirror cap left	Stone chip	Slight	
7	Door FL	Scratch	Slight	
8	Door RL	Scratch	Slight	
9	Door FR	Scratch	Slight	
10	Bumper front	Scratch	Severe
