REPORTNUMBER: 202404-25928

Report

Subject	Report
Inspection date/location	15.04.2024 Dick Automobile e.K., Ernst-Abbe-Str. 2, DE-36179 Bebra
Client	Dick Automobile e.K., Otto-Hahn-Str. 4-6, DE-36179 Bebra
Registration number	GI-TF 5000
Vehicle Identification Number	W1K2470121J292212

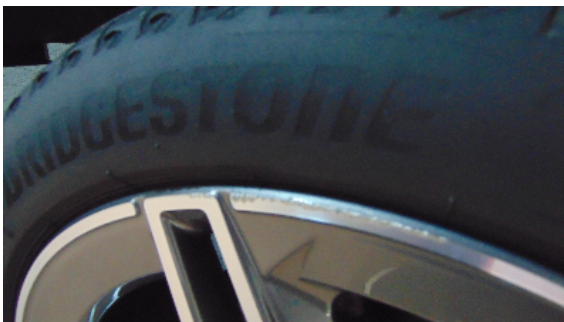
Image 1: siehe pos.1

Nr.	Component	Damage	Severity	Comment
1	Aluminium rim RR	Scratch	Medium	
2	Bonnet	Scratch	Slight	
3	Bumper front	Stone chip	Slight	
4	Fender ri	Stone chip	Slight	
5	Door RR	Scratch	Slight	
6	Bumper rear	Scratch	Slight	
7	Door RL	Scratch	Slight	
8	Door FL	Scratch	Slight
