REPORTNUMBER: 202504-30017

## Report

<b>Subject</b>	Report
<b>Inspection date/location</b>	09.04.2025   Dick Automobile e.K., Ernst-Abbe-Str. 2, DE-36179 Bebra
<b>Client</b>	Dick Automobile e.K., Otto-Hahn-Str. 4-6, DE-36179 Bebra
<b>Registration number</b>	GM-MA2476
<b>Vehicle Identification Number</b>	W1K1771121J369081

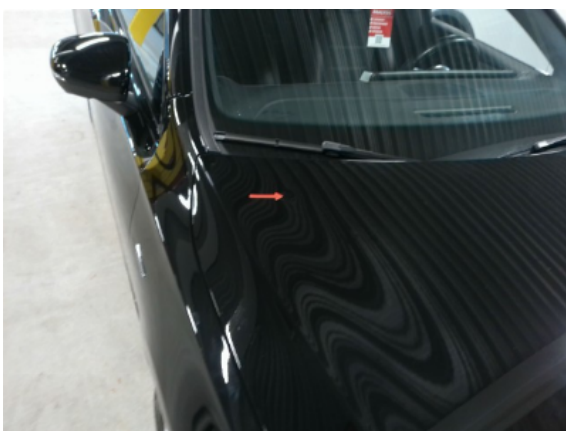
Image 1: Siehe Pos.1

Nr.	Component	Damage	Severity	Comment
1	Bonnet	Dent	Medium	
2	Bonnet	Stone chip	Slight	
3	Bumper front	Stone chip	Slight	
4	Mirror cap left	Stone chip	Slight	
5	Door FL	Scratch	Slight	
6	Bumper rear	Scratch	Slight	
7	Mirror cap right	Scratch	Slight
