REPORTNUMBER: 202405-26211

Report

Subject	Report
Inspection date/location	07.05.2024 Dick Automobile e.K., Ernst-Abbe-Str. 2, DE-36179 Bebra
Client	Dick Automobile e.K., Otto-Hahn-Str. 4-6, DE-36179 Bebra
Registration number	
Vehicle Identification Number	WDC1569081J477230

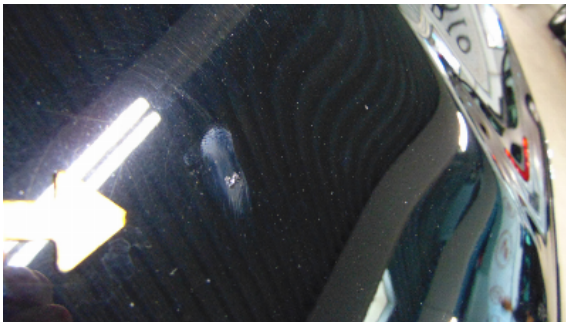
Image 1: siehe pos.1

Nr.	Component	Damage	Severity	Comment
1	Bonnet	Stone chip	Slight	
2	Bumper front	Stone chip	Slight	
3	Side panel right	Scratch	Slight	
4	Tailgate panel	Scratch	Slight	
5	Door RL	Scratch	Slight	
6	Door FL	Scratch	Slight	
7	Aluminium rim FR	Scratch	Medium	
8	Aluminium rim RR	Scratch	Medium	
9	Aluminium rim FL	Scratch	Medium
