REPORTNUMBER: 202403-25648

Report

Subject	Report
Inspection date/location	22.03.2024 Dick Automobile e.K., Ernst-Abbe-Str. 2, DE-36179 Bebra
Client	Dick Automobile e.K., Otto-Hahn-Str. 4-6, DE-36179 Bebra
Registration number	CB-MJ 242
Vehicle Identification Number	WF0FXXWPCFKU82601

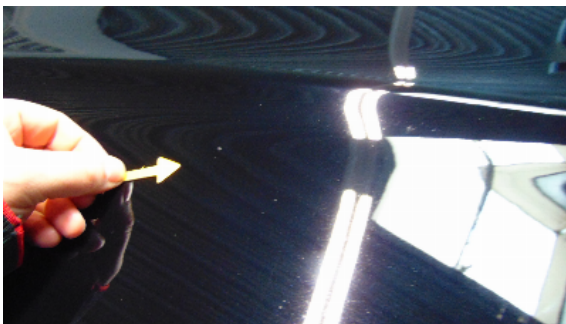
Image 1: siehe pos.1

Nr.	Component	Damage	Severity	Comment
1	Bonnet	Stone chip	Slight	
2	Bumper front	Stone chip	Slight	
3	Bumper rear	Scratch	Slight	
4	Door RL	Scratch	Slight	
5	Door FL	Scratch	Slight
