REPORTNUMBER: 202404-25940

Report

Subject	Report
Client	Dick Automobile e.K., Otto-Hahn-Str. 4-6, DE-36179 Bebra
Inspection date/location	15.04.2024 Dick Automobile e.K., Ernst-Abbe-Str. 2, DE-36179 Bebra
Registration number	
Vehicle type	Estate Car
Manufacturer	Ford
Model / Sales description	Ecosport 1.5 ECOBLUE
Key numbers HSN/TSN	/
Vehicle identification number	WF01XXERK1LB47675
Previous owners	
First registration	13.03.2020
Mileage	174.036 km
Colour / Colour Code	SILBER
Fuel Type	Diesel
Cubic Capacity / Power	1.496 cm ³ / 88 kW
Number of doors / seats	5 / 5
Transmission	Manual gearbox
Number of keys	1
Last maintenance	Unknown
Next vehicle inspection	01.03.2025
Service documentation	Nonexistent
Trailer coupling	No
Rain sensor	Available
Operating manual	Available
Repainting	Not Found
	Plastic parts could not be evaluated by means of paint thickness measurement.
Inspection Condition	non-dismantled, roadworthy, traffic safe

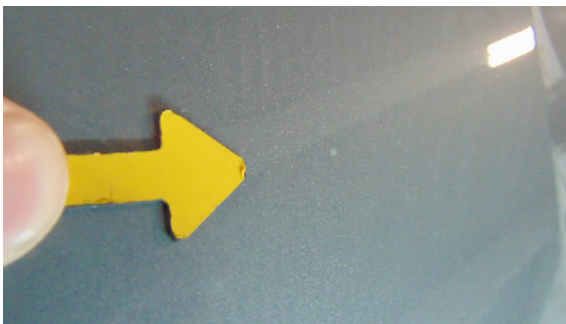
Image 1: siehe pos.1

Nr.	Component	Damage	Severity	Comment
1	Bonnet	Stone chip	Slight	
2	Bumper front	Stone chip	Slight	
3	Door FR	Scratch	Slight	
4	Bumper rear	Scratch	Slight	
5	Tailgate panel	Scratch	Slight
