REPORTNUMBER: 202404-25789

Report

Subject	Report
Inspection date/location	03.04.2024 Dick Automobile e.K., Ernst-Abbe-Str. 2, DE-36179 Bebra
Client	Dick Automobile e.K., Otto-Hahn-Str. 4-6, DE-36179 Bebra
Registration number	MTK-XG 506
Vehicle Identification Number	WAUZZZF22KN076302

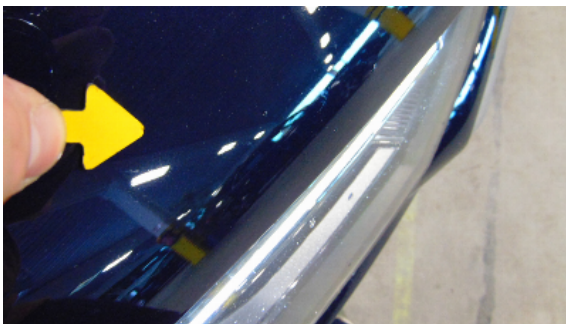
Image 1: siehe pos.1

Nr.	Component	Damage	Severity	Comment
1	Bonnet	Stone chip	Slight	
2	Bumper front	Stone chip	Slight	
3	Tailgate panel	Scratch	Slight	
4	Bumper rear	Scratch	Slight	
5	Fender le	Scratch	Slight
