REPORTNUMBER: 202403-25529

Report

Subject	Report
Client	Dick Automobile e.K., Otto-Hahn-Str. 4-6, DE-36179 Bebra
Inspection date/location	14.03.2024 Dick Automobile e.K., Ernst-Abbe-Str. 2, DE-36179 Bebra
Registration number	GTH-LL 270
Vehicle type	Estate Car
Manufacturer	VW
Model / Sales description	Golf VARIANT 2.0 TDI BLUEMOTION TECHNOLOGY DSG
Key numbers HSN/TSN	0603 / BOD
Vehicle identification number	WVWZZZAUZGP633632
Previous owners	4
First registration	04.10.2016
Mileage	134.752 km
Colour / Colour Code	BLAU
Fuel Type	Diesel
Cubic Capacity / Power	1.968 cm ³ / 110 kW
Number of doors / seats	5 / 5
Transmission	Automatic transmission
Number of keys	2
Last maintenance	22.08.2023 / 133.143 km
Next vehicle inspection	01.06.2024
Service documentation	Nonexistent
Trailer coupling	No
Rain sensor	Available
Operating manual	Unavailable
Repainting	Found Plastic parts could not be evaluated by means of paint thickness measurement.
Inspection Condition	non-dismantled, roadworthy, traffic safe

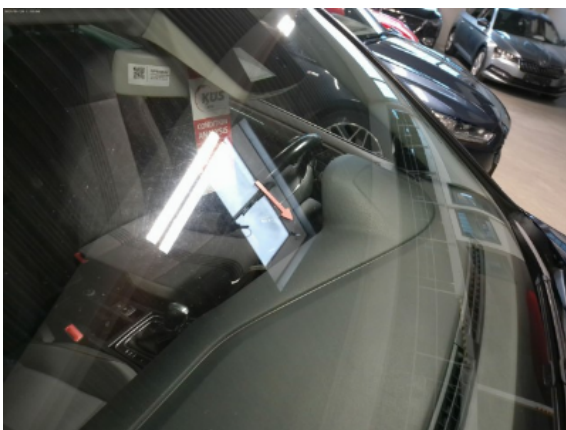
Image 1: Siehe Pos.1

Nr.	Component	Damage	Severity	Comment
1	Windshield	Stone chip	Slight	
2	Bonnet	Stone chip	Slight	
3	Bumper front	Stone chip	Slight	
4	Roof	Stone chip	Severe	
5	Door FL	Scratch	Slight	
6	Bumper rear	Scratch	Severe	
7	Door FR	Scratch	Slight
