REPORTNUMBER: 202404-25924

Report

Subject	Report
Inspection date/location	15.04.2024 Dick Automobile e.K., Ernst-Abbe-Str. 2, DE-36179 Bebra
Client	Dick Automobile e.K., Otto-Hahn-Str. 4-6, DE-36179 Bebra
Registration number	
Vehicle Identification Number	VSSZZZKLZMR014255

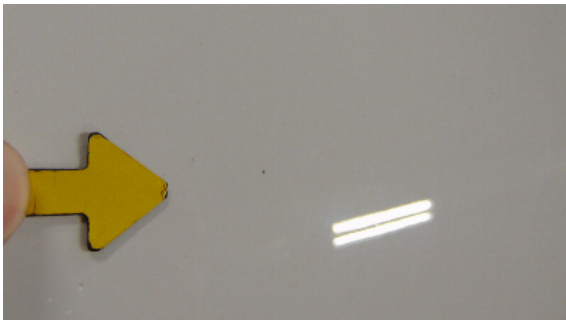
Image 1: siehe pos.1

Nr.	Component	Damage	Severity	Comment
1	Bonnet	Stone chip	Slight	
2	Bumper front	Stone chip	Slight	
3	Bumper rear	Scratch	Slight	
4	Tailgate panel	Scratch	Slight	
5	Roof	Dent	Slight
