REPORTNUMBER: 202404-25874

Report

Subject	Report
Inspection date/location	10.04.2024 Dick Automobile e.K., Ernst-Abbe-Str. 2, DE-36179 Bebra
Client	Dick Automobile e.K., Otto-Hahn-Str. 4-6, DE-36179 Bebra
Registration number	FRI-EV 708
Vehicle Identification Number	VSSZZZ5FZHR029468

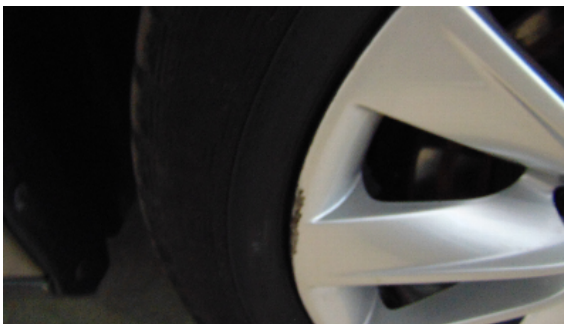
Image 1: siehe pos.1

Nr.	Component	Damage	Severity	Comment
1	Aluminium rim FR	Scratch	Medium	
2	Bonnet	Stone chip	Slight	
3	Door RR	Scratch	Slight	
4	Door RL	Dent	Slight
