REPORTNUMBER: 202403-25559

Report

Subject	Report
Client	Dick Automobile e.K., Otto-Hahn-Str. 4-6, DE-36179 Bebra
Inspection date/location	15.03.2024 Dick Automobile e.K., Ernst-Abbe-Str. 2, DE-36179 Bebra
Registration number	
Vehicle type	Saloon
Manufacturer	Seat
Model / Sales description	Ibiza 1.0 TSI S&S DSG
Key numbers HSN/TSN	/
Vehicle identification number	VSSZZZKJZLR098333
Previous owners	
First registration	15.01.2020
Mileage	105.775 km
Colour / Colour Code	Orange
Fuel Type	Petrol
Cubic Capacity / Power	999 cm ³ / 85 kW
Number of doors / seats	5 / 5
Transmission	Automatic transmission
Number of keys	2
Last maintenance	Unknown
Next vehicle inspection	01.01.2025
Service documentation	Nonexistent
Trailer coupling	No
Rain sensor	Available
Operating manual	Available
Repainting	Found Plastic parts could not be evaluated by means of paint thickness measurement.
Inspection Condition	non-dismantled, roadworthy, traffic safe

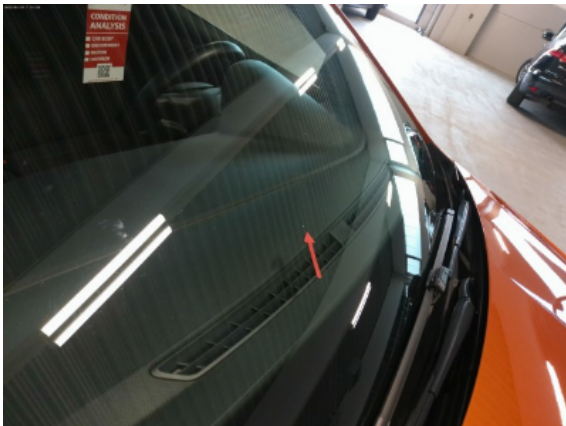
Image 1: Siehe Pos.1

Nr.	Component	Damage	Severity	Comment
1	Windshield	Stone chip	Slight	
2	Bonnet	Stone chip	Slight	
3	Bumper front	Stone chip	Slight	
4	Bumper front	Scratch	Severe	
5	Door RL	Scratch	Slight	
6	Bumper rear	Scratch	Slight	
7	Door FR	Scratch	Slight
