REPORTNUMBER: 202405-26181

Report

Subject	Report
Client	Dick Automobile e.K., Otto-Hahn-Str. 4-6, DE-36179 Bebra
Inspection date/location	03.05.2024 Dick Automobile e.K., Ernst-Abbe-Str. 2, DE-36179 Bebra
Registration number	
Vehicle type	Estate Car
Manufacturer	Peugeot
Model / Sales description	5008 1.5 BLUEHDI 130 ALLURE LTD
Key numbers HSN/TSN	/
Vehicle identification number	VF3MCYHZJKS393233
Previous owners	1
First registration	06.12.2019
Mileage	84.554 km
Colour / Colour Code	WEISS
Fuel Type	Diesel
Cubic Capacity / Power	1.499 cm ³ / 96 kW
Number of doors / seats	5 / 5
Transmission	Manual gearbox
Number of keys	2
Last maintenance	23.06.2022 / 58.663 km
Next vehicle inspection	
Service documentation	Available
Trailer coupling	Detachable
Rain sensor	Available
Operating manual	Available
Repainting	Not Found
	Plastic parts could not be evaluated by means of paint thickness measurement.
Inspection Condition	non-dismantled, roadworthy, traffic safe

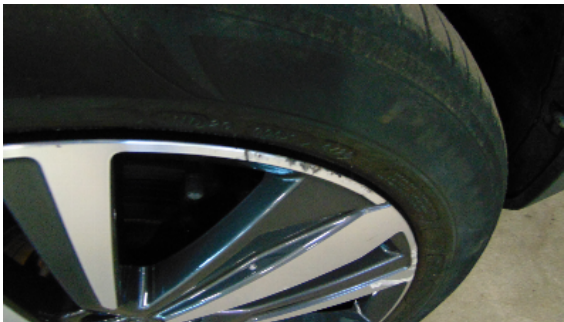
Image 1: siehe pos.1

Nr.	Component	Damage	Severity	Comment
1	Aluminium rim FR	Scratch	Medium	
2	Aluminium rim FL	Scratch	Medium	
3	Bumper front	Scratch	Medium	
4	Door entry RR	Scratch	Medium	
5	Side panel right	Scratch	Medium	
6	Door entry RL	Scratch	Medium
