REPORTNUMBER: 202404-25898

## Report

<b>Subject</b>	Report
<b>Inspection date/location</b>	11.04.2024   Dick Automobile e.K., Ernst-Abbe-Str. 2, DE-36179 Bebra
<b>Client</b>	Dick Automobile e.K., Otto-Hahn-Str. 4-6, DE-36179 Bebra
<b>Registration number</b>	SL-MX 1298
<b>Vehicle Identification Number</b>	WVWZZZAUZJW135312

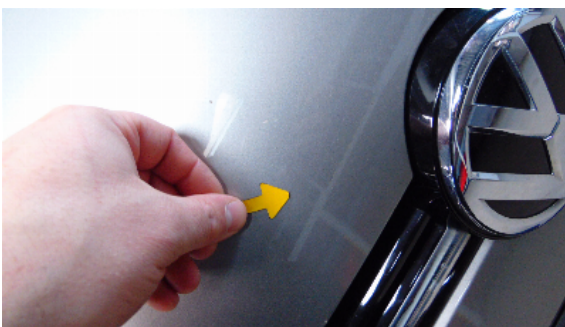
Image 1: siehe pos.1

Nr.	Component	Damage	Severity	Comment
1	Bonnet	Stone chip	Slight	
2	Bumper front	Stone chip	Slight	
3	Bumper rear	Scratch	Slight	
4	Tailgate	Scratch	Slight	
5	Door FL	Scratch	Slight
