REPORTNUMBER: 202404-26088

Report

Subject	Report
Inspection date/location	25.04.2024 Dick Automobile e.K., Ernst-Abbe-Str. 2, DE-36179 Bebra
Client	Dick Automobile e.K., Otto-Hahn-Str. 4-6, DE-36179 Bebra
Registration number	L-UO 1094
Vehicle Identification Number	JN1TGAT32U0001045

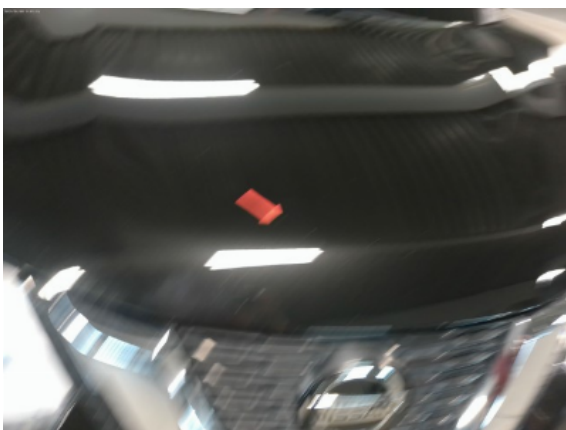
Image 1: Siehe Pos.1

Nr.	Component	Damage	Severity	Comment
1	Bonnet	Stone chip	Slight	
2	Bumper front	Stone chip	Slight	
3	Fender le	Stone chip	Slight	
4	Door entry FL	Scratch	Medium	
5	Bumper rear	Scratch	Slight	
6	Door RR	Scratch	Slight	
7	Fender ri	Stone chip	Slight
