REPORTNUMBER: 202405-26194

## Report

<b>Subject</b>	Report
<b>Inspection date/location</b>	06.05.2024   Dick Automobile e.K., Ernst-Abbe-Str. 2, DE-36179 Bebra
<b>Client</b>	Dick Automobile e.K., Otto-Hahn-Str. 4-6, DE-36179 Bebra
<b>Registration number</b>	FS-UT 320
<b>Vehicle Identification Number</b>	VNVF4000268684178

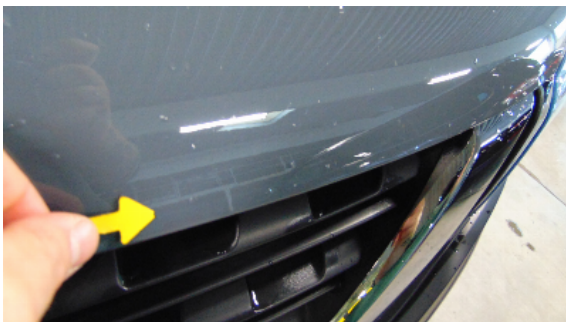
Image 1: siehe pos.1

Nr.	Component	Damage	Severity	Comment
1	Bonnet	Stone chip	Slight	
2	Bumper front	Scratch	Slight	
3	Mirror cap right		Severe	
4	Side panel right	Scratch	Slight	
5	Tailgate	Scratch	Slight	
6	Mirror cap left	Scratch	Slight
