REPORTNUMBER: 202605-33302

Report

Subject	Report
Inspection date/location	04.05.2026 Dick Automobile e.K., Ernst-Abbe-Str. 2, DE-36179 Bebra
Client	Dick Automobile e.K., Otto-Hahn-Str. 4-6, DE-36179 Bebra
Registration number	LB-FM 4756
Vehicle Identification Number	TMAJB81BANJ146272

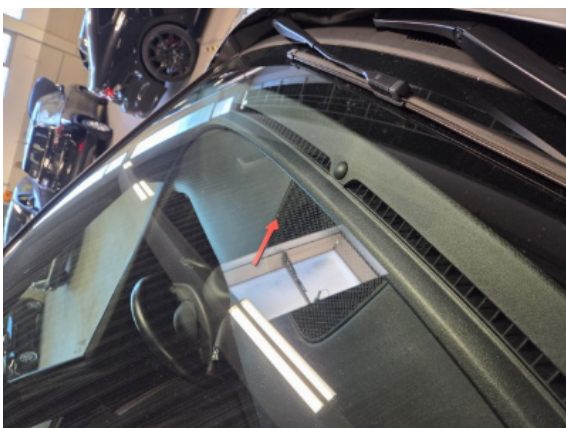
Image 1: Siehe Pos.1

Nr.	Component	Damage	Severity	Comment
1	Windshield	Stone chip	Slight	
2	Bonnet	Stone chip	Slight	
3	Seat FL	Scratch	Slight
