REPORTNUMBER: 202405-26224

## Report

<b>Subject</b>	Report
<b>Inspection date/location</b>	08.05.2024   Dick Automobile e.K., Ernst-Abbe-Str. 2, DE-36179 Bebra
<b>Client</b>	Dick Automobile e.K., Otto-Hahn-Str. 4-6, DE-36179 Bebra
<b>Registration number</b>	HH-CP1093
<b>Vehicle Identification Number</b>	YV1UZ68UCJ1115681

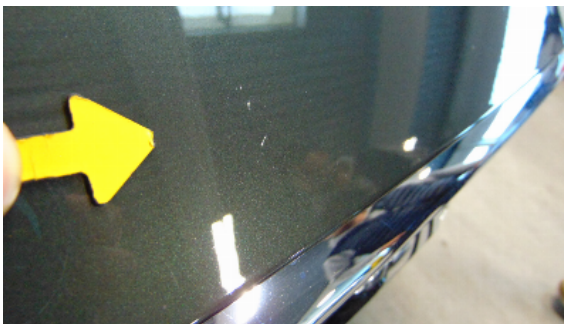
Image 1: siehe pos.1

Nr.	Component	Damage	Severity	Comment
1	Bonnet	Stone chip	Slight	
2	Bumper front	Stone chip	Slight	
3	Tailgate panel	Scratch	Slight	
4	Bumper rear	Scratch	Slight	
5	Door entry RL	Scratch	Slight
