REPORTNUMBER: 202404-25795

Report

Subject	Report
Inspection date/location	04.04.2024 Dick Automobile e.K., Ernst-Abbe-Str. 2, DE-36179 Bebra
Client	Dick Automobile e.K., Otto-Hahn-Str. 4-6, DE-36179 Bebra
Registration number	B-PE 292
Vehicle Identification Number	YV1UZK5VCM1740476

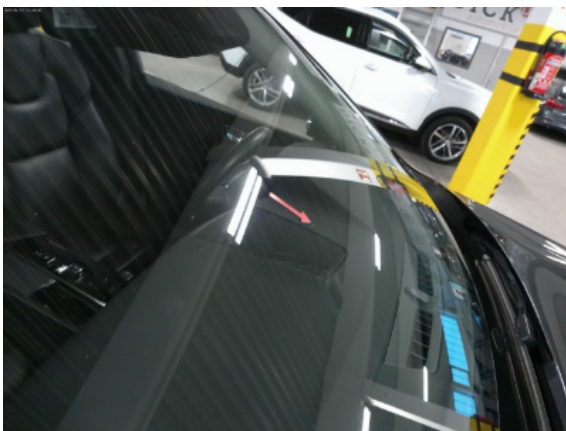
Image 1: Siehe Pos.1

Nr.	Component	Damage	Severity	Comment
1	Windshield	Stone chip	Slight	
2	Bonnet	Stone chip	Slight	
3	Bumper front	Stone chip	Slight	
4	Fender le	Stone chip	Slight	
5	Door FL	Scratch	Slight	
6	Bumper rear	Scratch	Slight	
7	Door RR	Scratch	Slight
