REPORTNUMBER: 202404-26021

Report

Subject	Report
Inspection date/location	22.04.2024 Dick Automobile e.K., Ernst-Abbe-Str. 2, DE-36179 Bebra
Client	Dick Automobile e.K., Otto-Hahn-Str. 4-6, DE-36179 Bebra
Registration number	D-CC195
Vehicle Identification Number	TMBLM7NU4L2019505

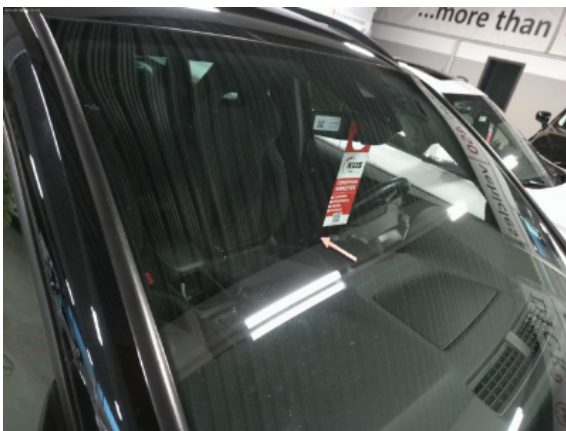
Image 1: Siehe Pos.1

Nr.	Component	Damage	Severity	Comment
1	Windshield	Stone chip	Slight	
2	Bonnet	Stone chip	Medium	
3	Bumper front	Stone chip	Medium	
4	Fender le	Stone chip	Slight	
5	Mirror cap left	Stone chip	Slight	
6	Tailgate		Severe	
7	Bumper rear	Scratch	Slight	
8	Door RR	Dent	Medium	
9	Mirror cap right	Stone chip	Slight	
10	Fender ri	Stone chip	Slight
