REPORTNUMBER: 202501-28952

Report

Subject	Report
Inspection date/location	08.01.2025 Dick Automobile e.K., Ernst-Abbe-Str. 2, DE-36179 Bebra
Client	Dick Automobile e.K., Otto-Hahn-Str. 4-6, DE-36179 Bebra
Registration number	D-QZ1874
Vehicle Identification Number	JTJYWRBZ702049067

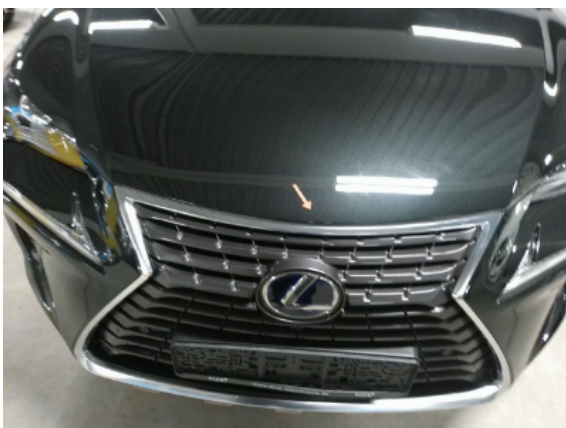
Image 1: Siehe Pos.1

Nr.	Component	Damage	Severity	Comment
1	Bonnet	Stone chip	Slight	
2	Bumper front	Stone chip	Slight	
3	Mirror cap left	Stone chip	Slight	
4	Door FL	Scratch	Slight	
5	Door RL	Scratch	Slight	
6	Door entry RL	Scratch	Medium	
7	Bumper rear	Scratch	Slight	
8	Door RR	Stone chip	Slight	
9	Mirror cap right	Crack	Severe
